NASA TM X- 55516

# LOCALIZED OVERHEATING IN AEROBEE REGENERATIVELY COOLED THRUST CHAMBERS

JON R. BUSSE  
PAUL S. BUSHNELL, JR.

GODDARD SPACE FLIGHT CENTER  
GREENBELT, MARYLAND

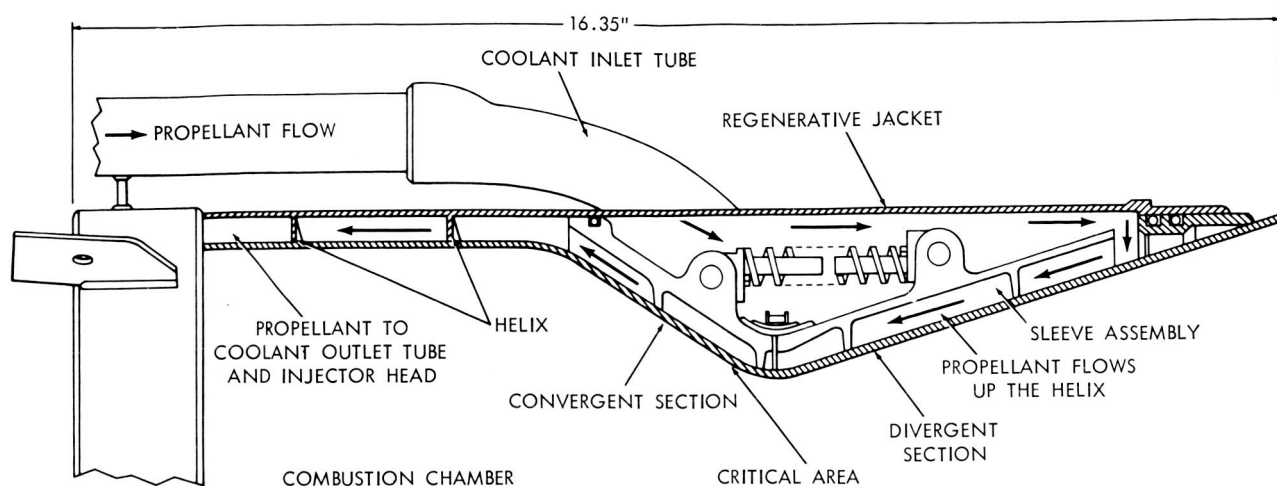
Figure 1 shows the thrust chamber with arrows indicating the flow direction of the fuel through the helix area within the thrust chamber jacket. The critical area in which overheating consistently occurs is also indicated. In almost all of the pictures presented in this report, the regenerative

Figure 1—Longitudinal view of half section of Aerobee thrust chamber indicating propellant flow.

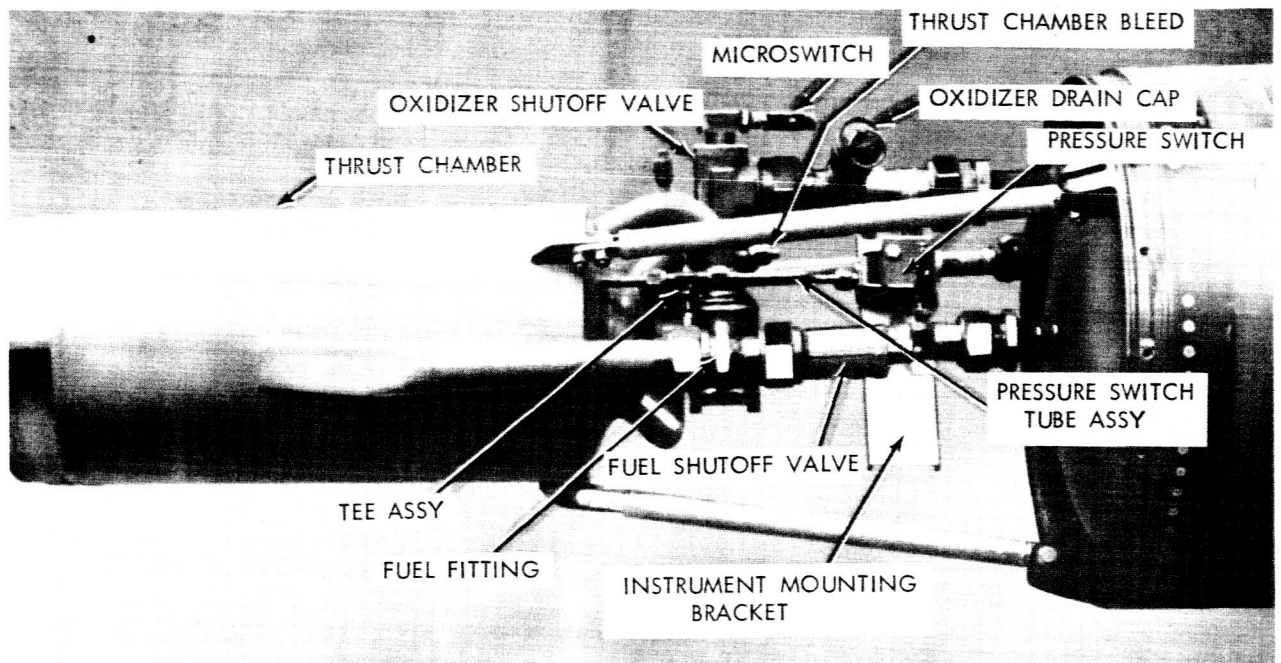
Figure 2—Tail assembly with location of propellant control fittings shown: (a) Aerobee 150; (b) Aerobee 150A.
